# Research and architectural conservation in Marina el-Alamein in 2018 (Polish–Egyptian Conservation Mission)

**Abstract:** Activities undertaken by the Polish–Egyptian Conservation Mission to Marina el-Alamein in 2018 comprised research and conservation mainly in the public district of the ancient town and, additionally, in private houses. Work focused foremost on research and presentation of remains of two streets, running east and south of the southeastern corner of the main town square, and the adjoining monuments. Research and conservation continued also on the remains of public Roman baths dating from the 1st to the 3rd century AD, located in the area south of the square. Maintenance conservation was carried out in Houses H21c and H1 and in the ancient town center. Land grading to enhance exhibition value and ensure rainwater drainage was carried out in some areas.

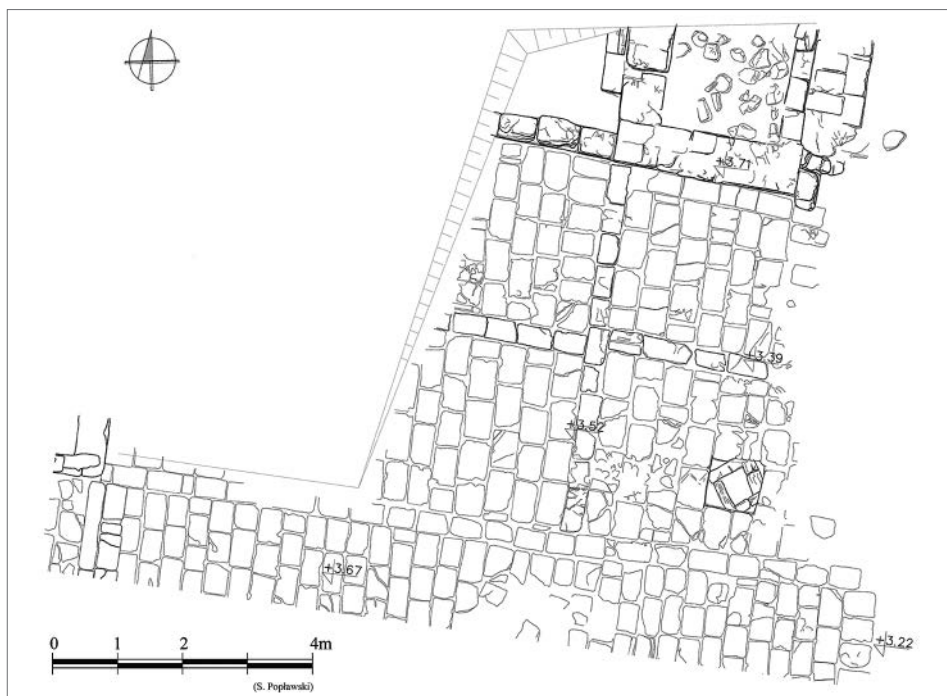
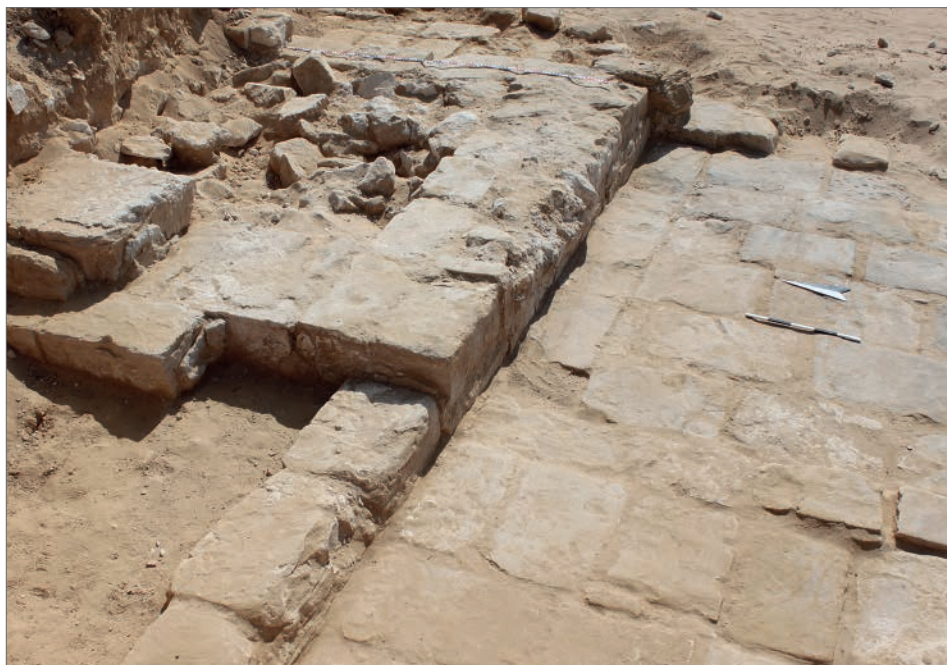
The uncovered remains constituted the southeastern corner of a building, in which several elements can be distinguished [see *Fig. 3*]. The south wall is roughly aligned with the stylobate of the southern portico of the peristyle adjoining the forum, situated about 20 m to the west [see *Fig. 2*]. Assuming that the north wall of the building would be aligned with the northern portico of the peristyle, the building would stretch for 7.80 m from north to south. However, the alignment is only approximate and the direction of the wall is slightly inclined in relation to the stylobate discussed. Further research is necessary.

Fig. 3. Part of the square and remains of structures siding the street running east from the forum: top, plan; bottom, the northern part after cleaning, looking east (Polish–Egyptian Conservation Mission Marina el-Alamein | photo R. Czerner, drawing S. Popławski)

The section cleared was roughly 2.30 m wide from south to north [*Fig. 4*]. The east part, 2.83 m long from east to west, constitutes the southern section of the wall perimeter. The south and west walls are thicker at the corner—0.67 m and 0.64 m respectively—whereas the east wall is only about 0.30 m thick. The west wall is the most massive and well made. Dressed blocks form the west and east walls, the south one is built of irregular stones. One course of blocks, 0.34 m high, survives in most of the feature, two courses in some places (about 0.60 m). Collapsed stone blocks filled the inside of the structure. Adjoining the east wall on the east is a platform, which is 0.88 m

wide and raised about 20 cm above the level of the pavement. It could be a kind of very wide step. A damaged stone drum of a column, about 0.50 m in diameter, found in the vicinity, may have come from the said building, and be it so, then the solid west wall may have been a stylobate.

A thinner wall (0.37–0.45 m wide) runs westward from the southwestern corner of the feature described above. Its direction is also slightly inclined in relation to the portico in the peristyle adjacent to the forum, but the difference could have been corrected in the westward section.

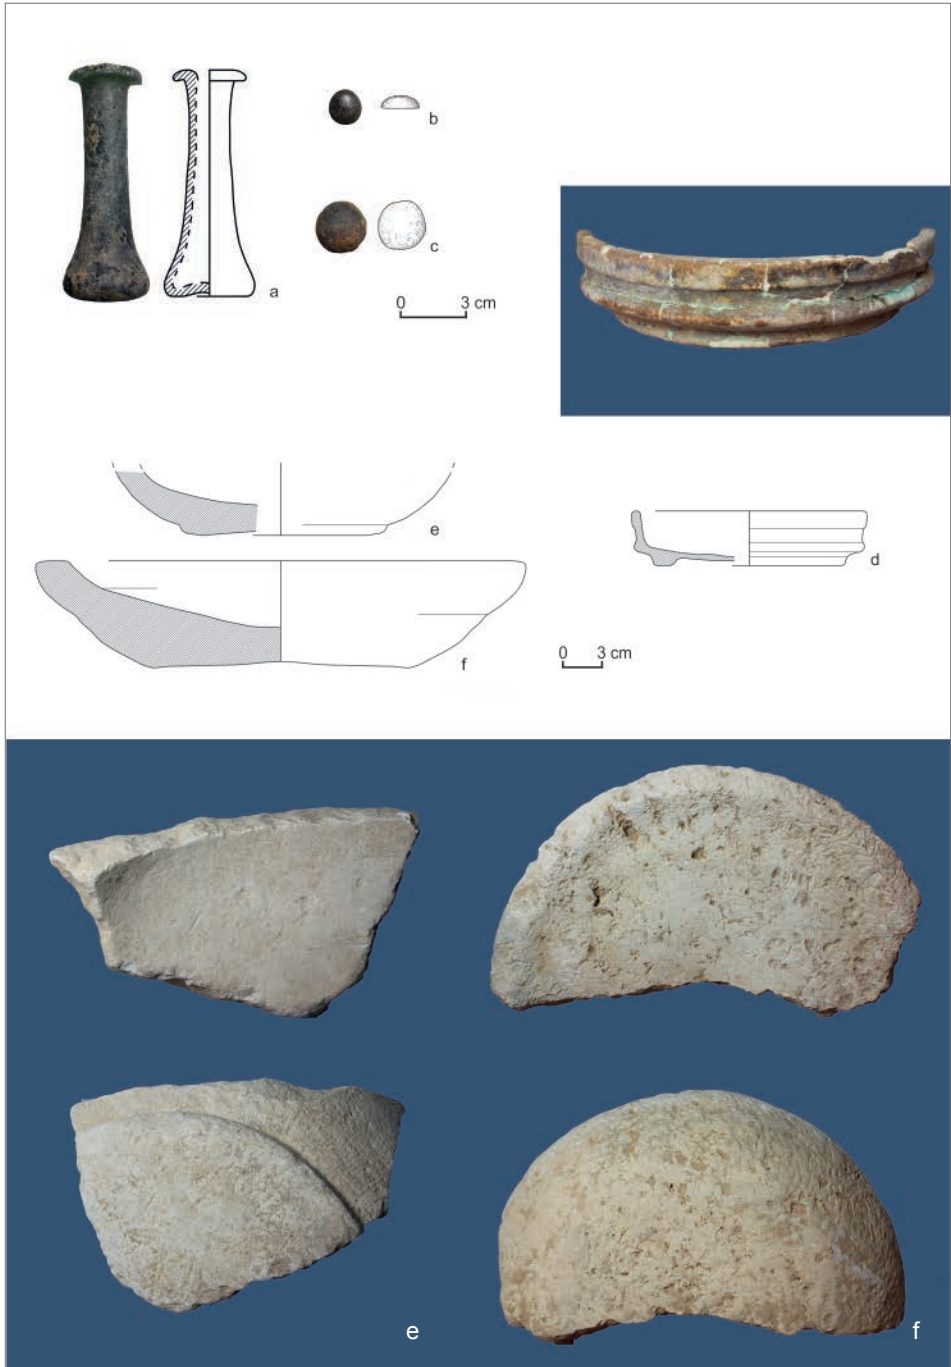
Fig. 4. Glass, faience and stone finds: a – glass unguentarium; b – glass game pawn; c – glass marble; d – faience plate; e, f – stone mortaria (Polish–Egyptian Conservation Mission Marina el-Alamein | drawing R. Bąkowski, photos R. Czerner)

Finds from the room behind the wall lining the south side of the street, recovered during the reconstruction work on the wall, included a glass pawn [Fig. 4:b] and a mortarium fragment [Fig. 4:e]. Oval pawns of this kind, slightly convex with black shiny surface (Dia. 1.6/1.4 cm, H. 0.6 cm), are fairly common (e.g., Nuțu and Boțan 2009: 148, 151, Pl. 2, Nos 2–4). The small fragment

of a limestone mortar has a base 15 cm in diameter and body walls smoothed inside with traces of treatment on the outside. The bottom was slightly concave, the foot profiled. The pottery from this context was dated to the 2nd through 3rd century AD (G. Majcherek, personal communication). In Marina, pawns and mortaria are frequent finds. Most of the mortars discovered in Marina date from this period.

a bright green glaze [Fig. 4:d]. According to Mieczysław Rodziewicz (2005: 30, 101), this is an imitation of an Eastern Sigillata form from the first half of the 1st century AD. Plates of this kind, attested also in Marina, were popular in Egypt in the 2nd century and the beginning of the 3rd century. Bones of animals, including camel, gazelle and birds, were also found in the room. Of the five bronze coins, two were legible, one being a Ptolemaic and the other a Hadrian issue.

A large mortarium of nummulithic limestone (the stone identified by geologist Małgorzata Mrozek-Wysocka) was found west of House H21 [see *Fig. 4:f*]. The bottom is slightly concave (unlike the other fragment) and the rim is flat and plain. With an 8 cm high shallow bowl and a diameter of approximately 37 cm (the usual diameter is 13–28 cm), it is the largest stone mortarium found in Marina so far. Although made for use primarily in housework, mortararia were also present in sanctuaries or for industrial purposes (for more on mortararia, see Villing 2009). They were used for pounding or mixing food, grinding cereals, but also for preparing medicines, mixing pigments or binding mortar.

An almost complete unguentarium [see *Fig. 4:a*] and a small marble sculpture fragment [*Fig. 11*] were found in the area east of the Roman baths. The statue frag-

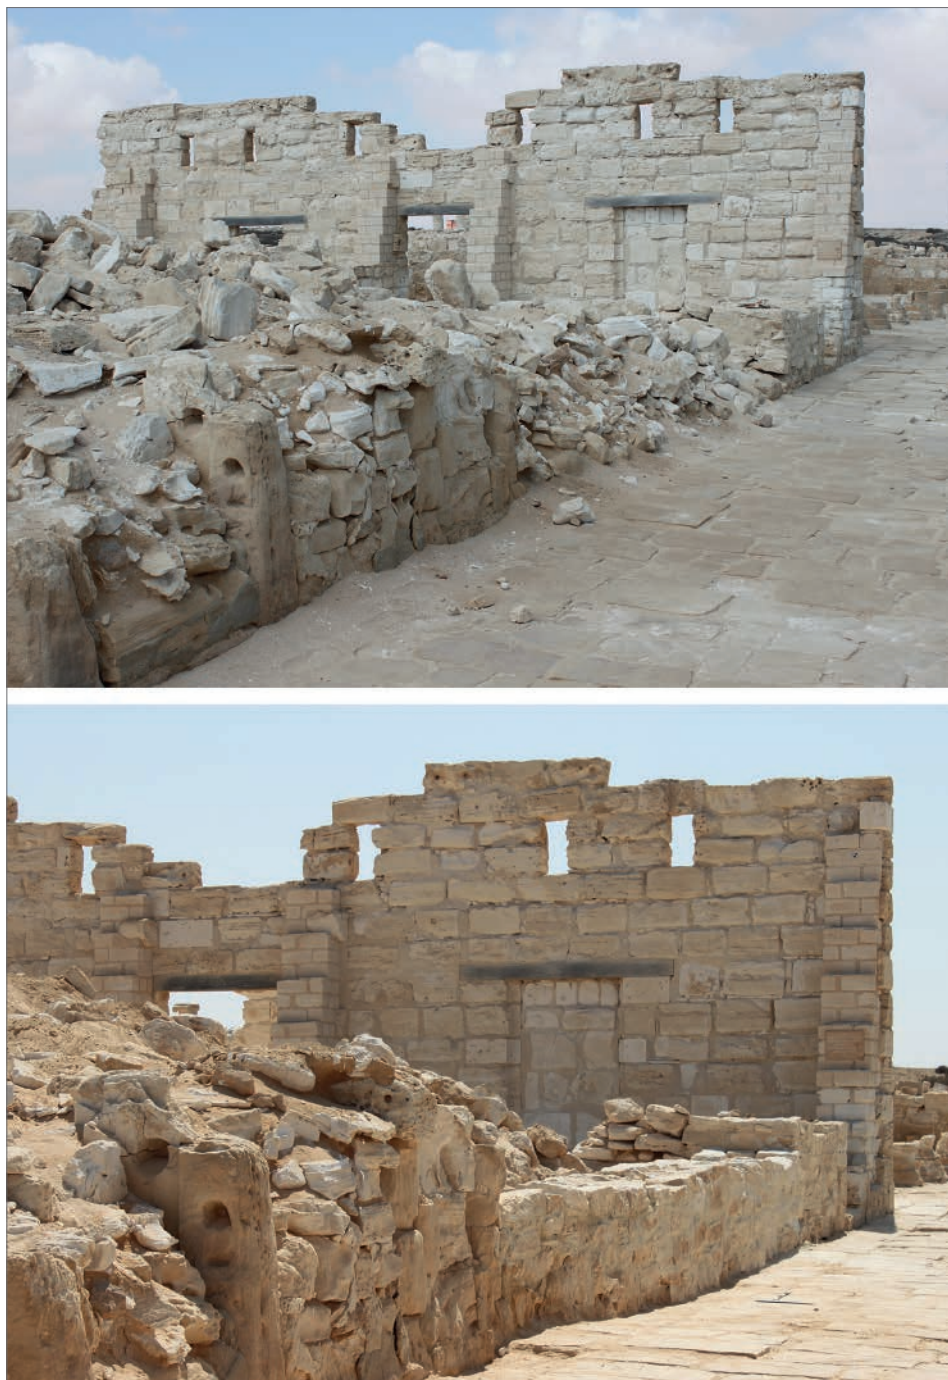
Fig. 5. South side of the street running east from the forum, view from the east: top, before preservation; bottom, after preservation in 2018 (Polish–Egyptian Conservation Mission Marina el-Alamein | photos R. Czerner)

The restoration started in the previous season with a wall on the northern side of the street, built in ashlar masonry. A short stretch of the southern elevation built of rubble masonry was protected then. In 2018, this wall was raised to a height of 0.65 m for a stretch 7.80 m long [Fig. 5]. In the eastern square work was limited to uncovering the paved surface.

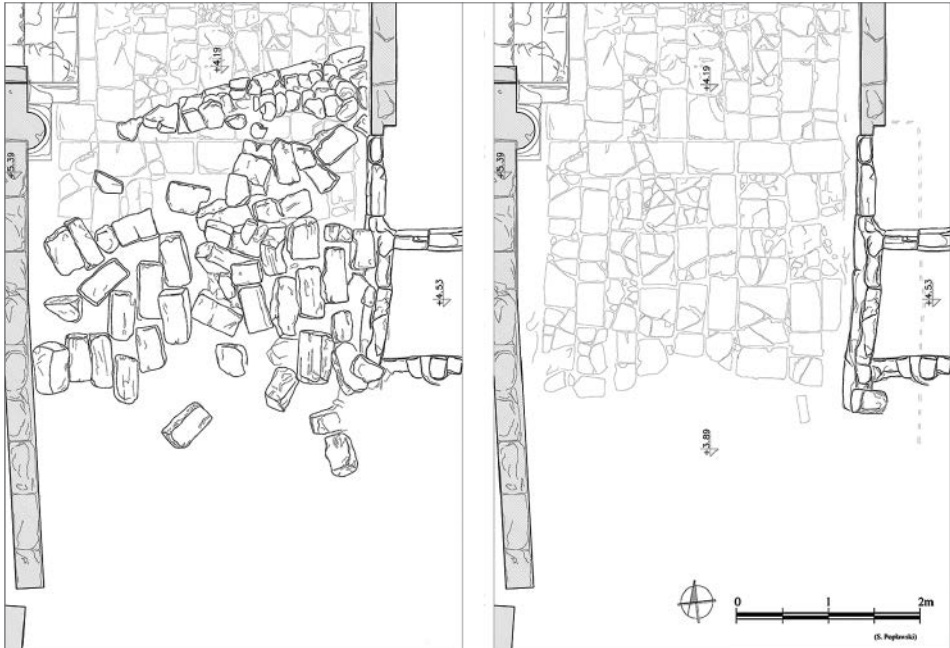
It was built of stone slabs (0.24 x 0.55 x 0.16 m) and screened off a room east of the street [Figs 6, 7 bottom]. The north wall of this unit was built of vertically placed slabs (0.36 x 0.60 x 0.14 m) covered with white plaster on the southern side. The entrance leading east, 0.90 m wide, was also blocked with a thin wall of similar slabs. A wider wall, perhaps of rubble stone, closed the room on the southern side. [RC]

Fig. 6. The south section of the street running south from the forum: left, before cleaning; right, after cleaning in 2018 (Polish–Egyptian Conservation Mission Marina el-Alamein | drawing S. Poplawski)

of the street. Loose stone blocks coming from both walls were cleaned and documented, then removed to uncover the street surface (3.68 m wide) [see Fig. 6]. Part of a room situated on the eastern side of the street was also uncovered [see Figs 6, 7 bottom]. Stone blocks from the basilica walls, which might have been the first to collapse, were lying on a layer of sand 5–10 cm thick or directly on the paving, whereas blocks slightly smaller in size, most probably coming from the east wall, were found on a layer of sand about 20–30 cm thick. Among the stone blocks coming from the east wall there were several elements of jambs and architectural elements. Plaster, mainly white and pale yellow in color, came from a layer of sand under the stone blocks. Traces of plaster (four layers) have survived *in situ* on the lower section of the basilica wall, right above the paving. The fill also yielded a small amount of animal bones, identified as sheep and gazelle, and a bronze coin of Antoninus Pius from the mid-2nd century, found under a stone block coming from the basilica wall (for more on the coins, see Lichočka 2019, in this volume). The walls of the basilica were evidently still standing at this time. The deposit of dark packed soil east of the east wall yielded pottery and glassware dated to the 2nd–3rd century (G. Majcherek and R. Kucharczyk, personal communication). Several oil lamp fragments were also found, as well as half of a faience plate, 16 cm in diameter, form T13.3 (Nenna and Seif el-Din 2000: 52, 323, 326, No. 473, Pl. 13; 2014: 280–281, Pl. 9), still preserving traces of

Cleaning the space revealed another section of the street and its paving. Blocks from the collapsed walls were documented and removed from the street, to be used later in a partial anastylosis of both walls. In 2018, two courses of blocks were added to the top of part of the wall on the western side of the street. One element was also added to the top of an engaged column flanking the entrance [see Fig. 7]. On the western side, south of the basilica, a relic of the southeastern corner of a vestibule (Room 9) leading to the baths was also protected with an extra course of stone blocks.

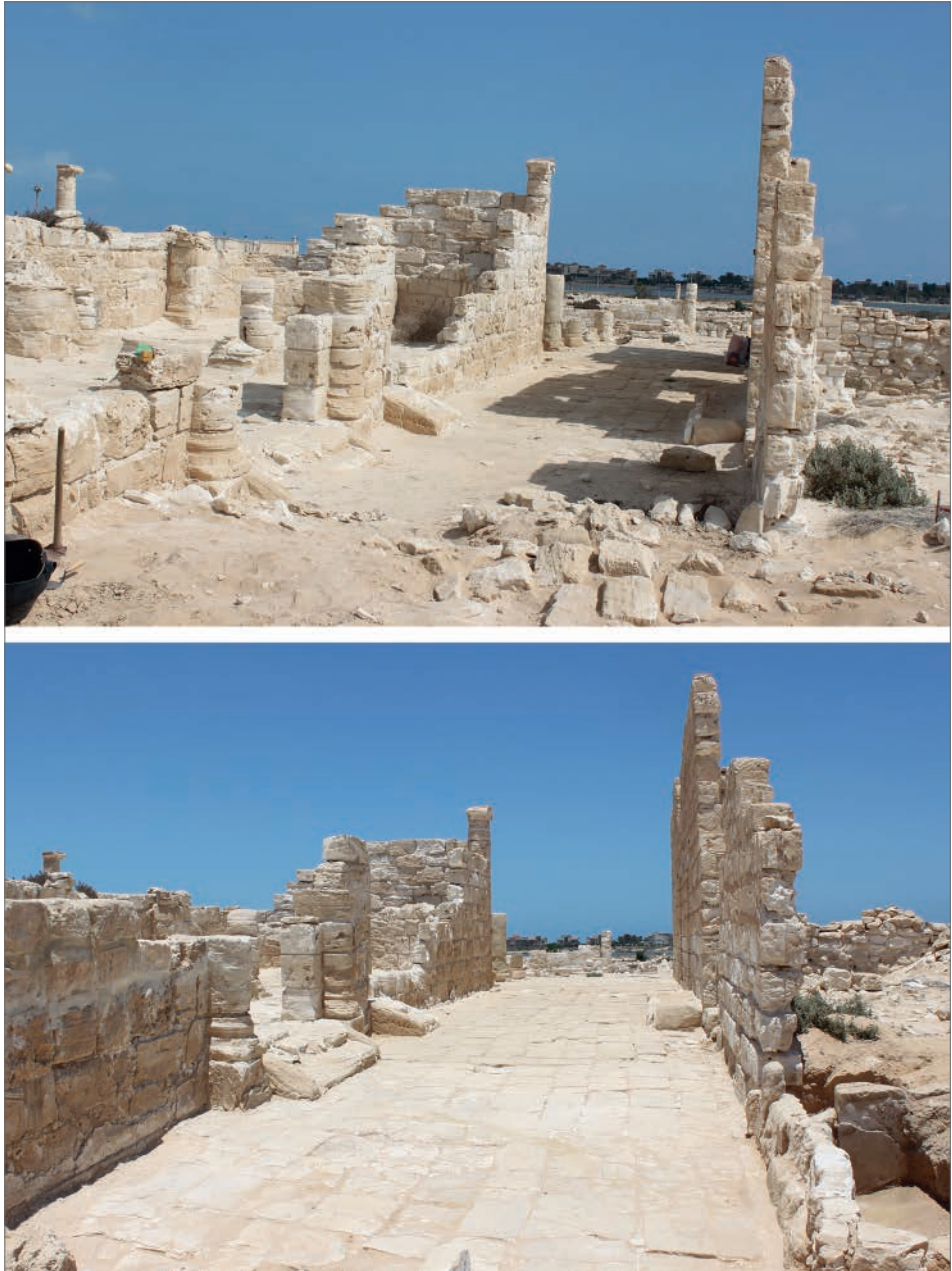
Fig. 7. Street running south from the forum, view from the south: top, before cleaning and preservation; bottom, after cleaning and preservation in 2018 (Polish–Egyptian Conservation Mission Marina el-Alamein | photos R. Czerner)

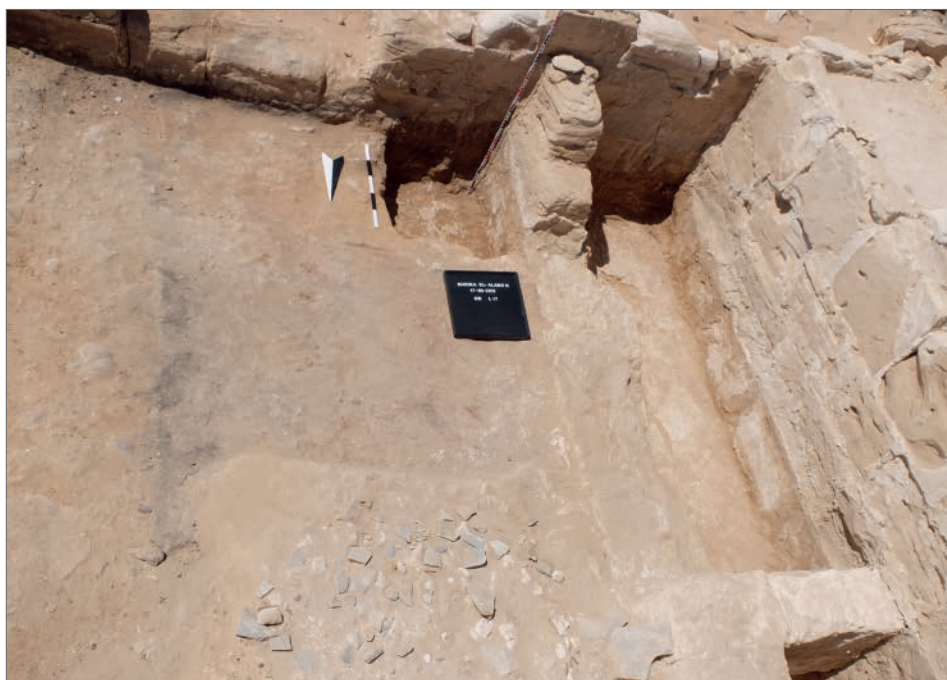
Fig. 8. Room 17 of the Roman baths south of the main square: view from the north (Polish–Egyptian Conservation Mission Marina el-Alamein | photo R. Czerner)

the northern door a severely damaged fragment of a floor made of marble tiles set in mortar [see Fig. 8]. It was the latest floor, lying about 12 cm above an earlier floor of lime mortar with ceramic filler. The dark burnt soil layer on this floor yielded a good many fragments of pottery and a clay oil lamp, glassware and animal bones, the latter including pig, camel, bird and fish remains, as well as small fragments of terracotta articles and a fragment of a bone pin. A small hearth was situated in the corner by the south wall, which used to support stairs. A fragment of damaged burnt grey marble turned out to be a piece of the right arm of a large sculpture. Relics found in this layer are dated to the 2nd century and the first half of the 3rd century.

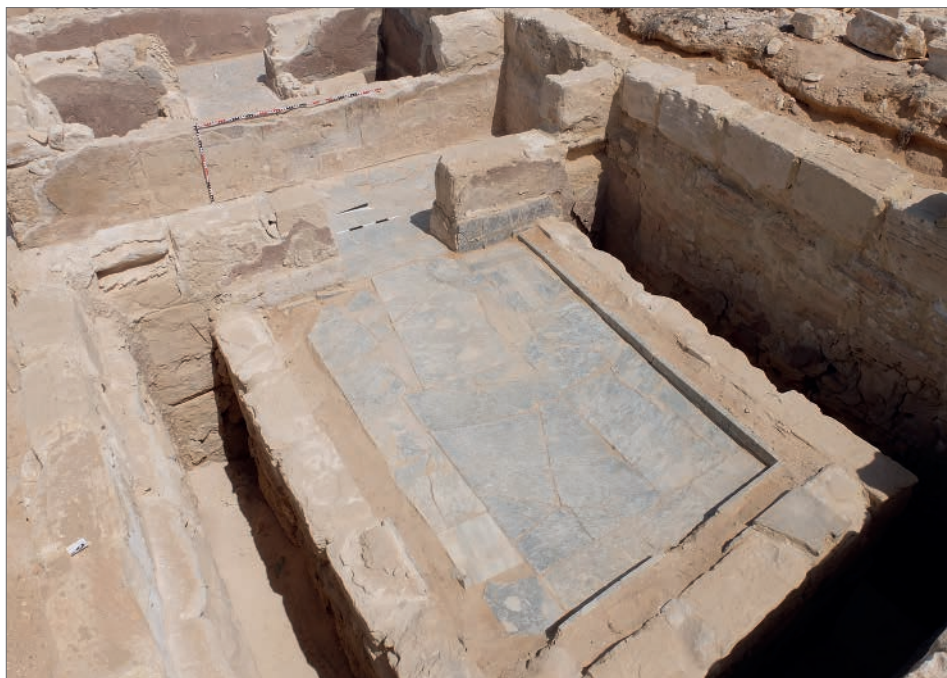
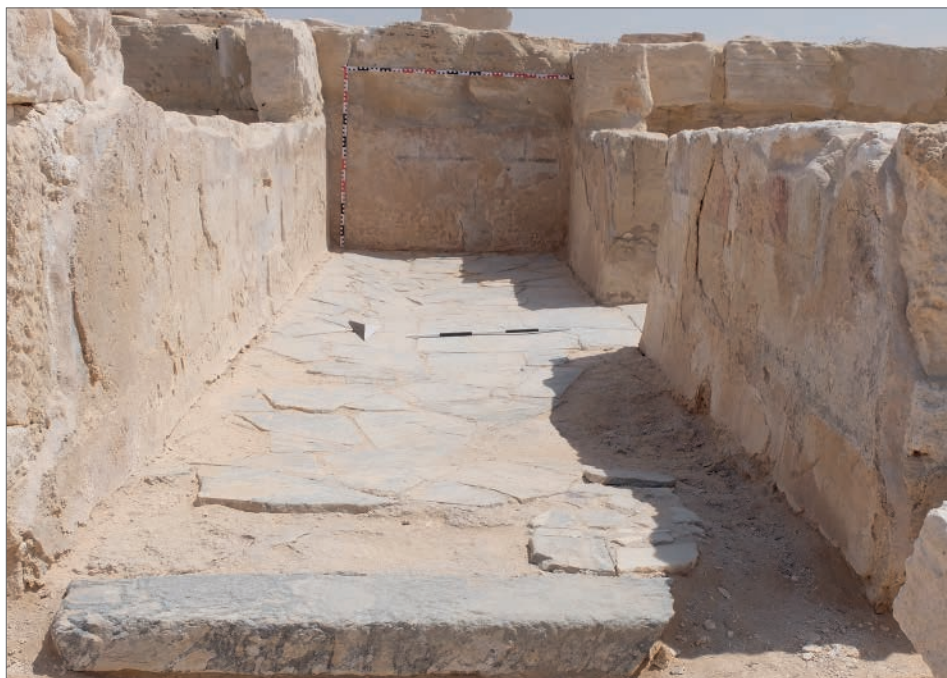
In 2018, Room 13 [Figs 9, 10], which used to be an entrance corridor to Latrine 12, was explored, revealing painted wall decoration on the lower parts of all the walls. The excavation of this unit had been postponed from 2013 (for the earlier research, see Czerner et al. 2015: 126; Bąkowska-Czerner and Czerner 2017: 181) in order for a painting restorer to be present during the investigation.

Fig. 9. Rooms 12 (latrine) and 13 of the Roman baths south of the main square: top, view from the west; bottom, view from the north (Polish–Egyptian Conservation Mission Marina el-Alamein | photos R. Czerner)

Earlier archaeological research in Room 13 of the bath, a corridor leading to the latrine (room 12), was halted upon discovering the painted wall decoration in this units (Czerner, Bąkowska-Czerner, and Majcherek 2015: 126) [see *Figs 9, 10*]. The walls survived to a height of about 0.57–1.00 m. Stone blocks from the collapsed wall lay in a layer of clean sand overlying an accumulation of mortar and plaster fragments, mostly white in color. Finds included ceramics and glass, dated mainly to the 2nd century through the mid-3rd century. The room is 3.75 m long, 1.02 m wide at the northern entrance and 1.05 m wide on the southern side. The door to the latrine was located more or less in the middle of the west wall; it was 0.76 m wide. The floor of the room was laid with irregular marble tiles [see *Fig. 9* bottom]. A threshold (0.11 m high, 0.13 m wide) remains in the northern entrance. The painted decoration [see *Figs 9* bottom, *10*]

comprised two layers of painted plaster coated with two layers of whitewash. The first paint layer is best preserved and most elaborate; it is associated with the decoration project of the baths as a whole. The east wall features a black band, 2 cm wide, running horizontally about 0.28 m above the floor, cutting off the dark-grey socle from the panels above, the latter imitating stone slabs of different colors: greenish, reddish and grey. The second paint layer, best preserved on the south wall, bears a simpler decoration. A black horizontal stripe, about 2 cm wide, runs 0.42 m above the floor separating the white wall below from vertical panels imitating decoration in stone. Yellow survives in the corners and an imitation of red stone appears in the middle. Plaster fragments found in the latrine (Room 12) and in Room 9 may come from this corridor (Czerner, Bąkowska-Czerner, and Majcherek 2015: 126–128, *Fig. 8*). Research by Anna Selerowicz, the team's conservator, who preserved the vestiges of the painting, improved the interpretation of this decoration (see Selerowicz and Zambrzycki 2019, in this volume).

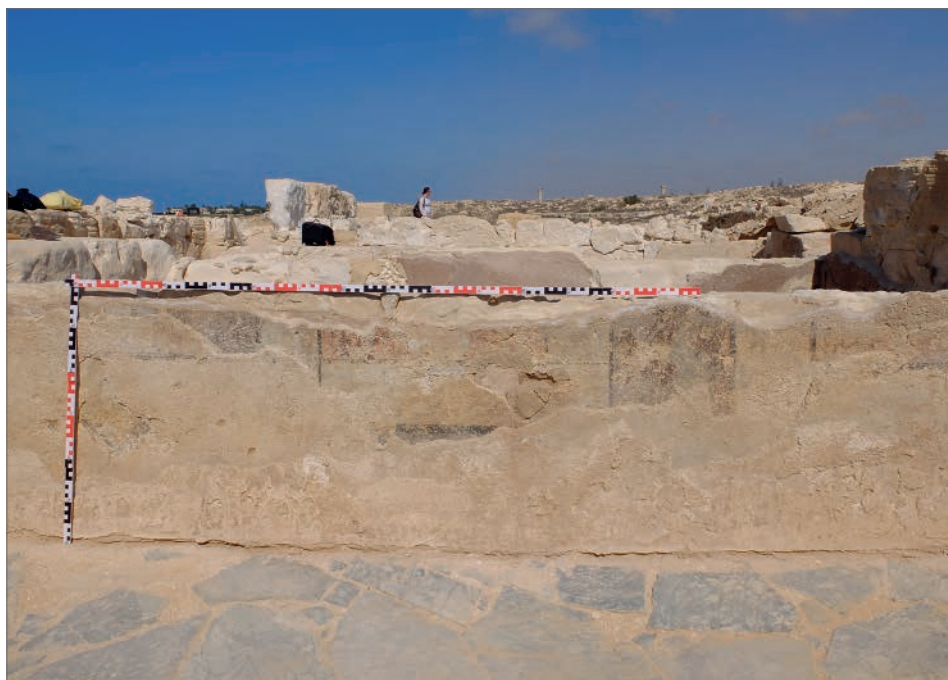
Fig. 10. East wall of Room 13 of the Roman baths south of the main square, with two layers of painting decoration (Polish–Egyptian Conservation Mission Marina el-Alamein | photo R. Czerner)

The baths were built towards the end of the 1st century or at the beginning of the 2nd century, and were destroyed around the middle of the 3rd century AD. During that time the corridor walls were covered with two layers of paint and then the damaged polychromy was coated with a double layer of white plaster. The interpretation of the decoration of the Roman baths will be enhanced by a better understanding of the wall painting in the corridor as well as other wall painting from the baths.

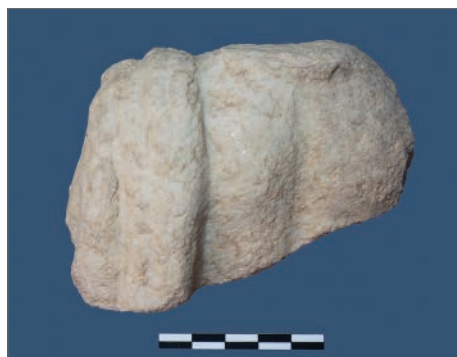
ment is a headless male torso, apparently with longer hair reaching to the shoulders. The front of the sculpture is heavily damaged, whereas its back, with a robe (himation) slung over the left shoulder, is well preserved. It could be a representation of a god, either Serapis, Asklepios or Zeus, all of whom tend to be imagined in this way. [GB-C]

Fig. 11. Fragment of a marble statuette (Polish–Egyptian Conservation Mission Marina el-Alamein | photo R. Czerner)
