# Conservation work in Marina el-Alamein in 2018 (Polish–Egyptian Conservation Mission)

**Abstract:** The article presents the program and results of continuous monitoring and preservation of historic architectural structures after the winter period at the site of Marina el-Alamein in Egypt, carried out by the Polish-Egyptian Conservation Mission. The program embraced studies of ancient plaster, polychromy and execution techniques employed for producing elements of sculptural and architectural decoration, as well as conservation of archaeological artifacts.

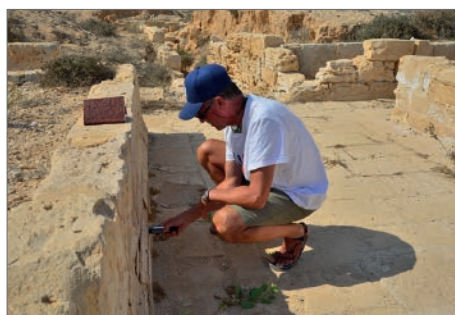
Fig. 1. Dampness study: left, thermovision measurements in the main square of the ancient town; right, wall humidity measurements being taken in Tomb T21 (Polish-Egyptian Conservation Mission | thermovision-image processing P. Zambrzycki, photo A. Selerowicz)

Wall moisture distribution was measured using an electrical resistance device in vertical axes. The axes were marked from the eastern, northern (sea direction) and western sides. Measuring point spacing was set between 20 and 30 cm, depending on wall structure. The research goal was to establish dampness distribution, analysing the walls near the soil and up to a height of approximately 1 meter. The top parts of the walls were measured in addition.

Thermal recording has shown temperature distribution, which in the earlier part of the day matched the dampness distribution of the walls and surrounding terrain. This has also provided valuable information regarding the temperature

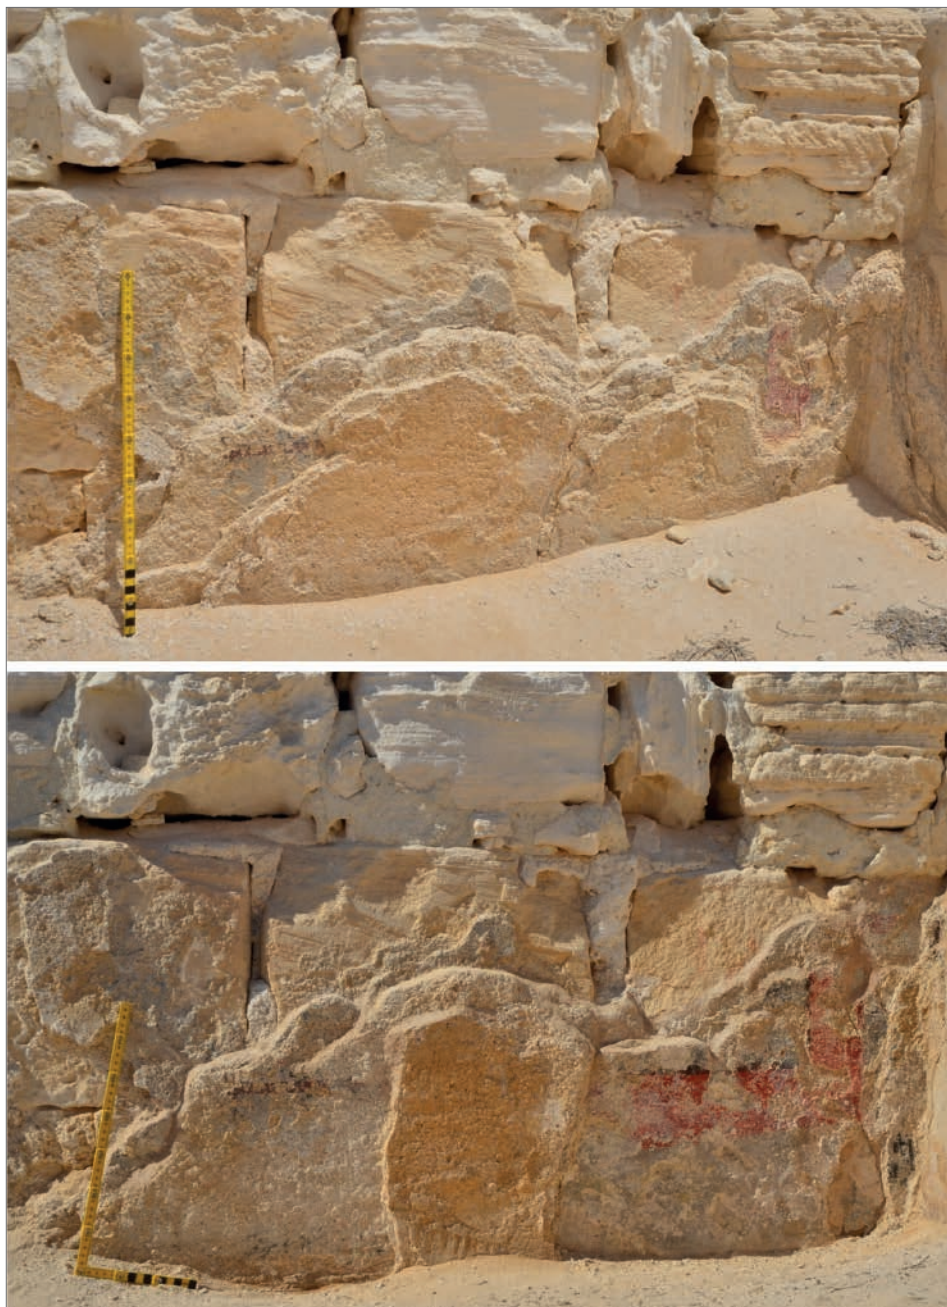
Several layers of decorated plaster of different degrees of cohesion are present on the lower walls of Corridor 11 of the Roman baths located south of the main town square in the central part of the site [Fig. 3]. The main threat to the integration of the layers are the unfavourable microclimatic conditions. Hence preventive action was undertaken aimed at reinforcing plaster adhesion to the substrate and protecting the surface of the polychromy.

Fig. 3. Northeastern corner of Room 11 in the Roman baths with preserved relics of plaster: top, before conservation; bottom, after conservation; note bands reinforcing the plaster edges (Polish–Egyptian Conservation Mission | photos P. Zambrzycki).

layers was established. The uncovered layers (in some places up to 10 layers were observed) were partly cleaned of depositions. Edges of losses were protected with bands of lime-cement mortar with sand and crushed brick filler, and a sprinkling of a 5% water solution of Primal AC33 as plasticizer. The polychromed plaster surface was reinforced with a 2% water solution of Primal AC33 (Jakubowski 2008: 130–131). The decorative layer is preserved in relatively good condition [Fig. 3 bottom]. Traces of cuts in this layer testify to ancient preparations for adding another plaster coating.

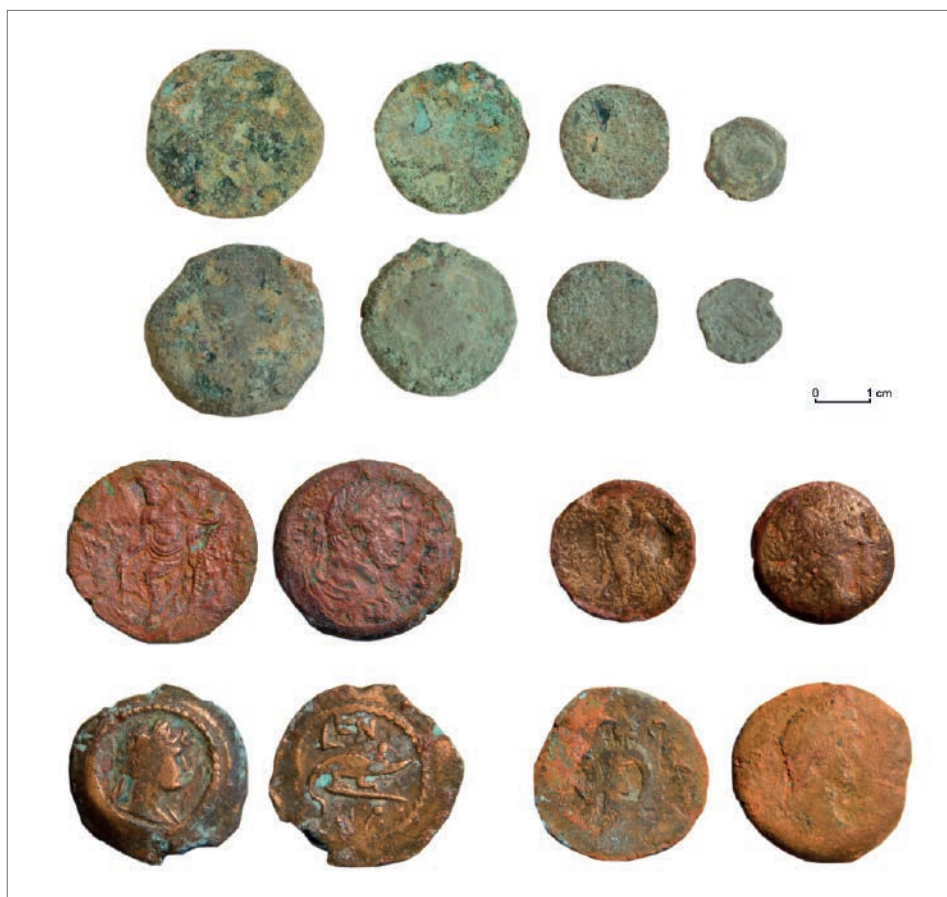
Fig.5. Bronze coins found in 2018: top, obverse and reverse, before conservation; bottom, same, after conservation (Polish–Egyptian Conservation Mission | photos P. Zambrzycki).

numismatist (see Lichočka 2019, in this volume) [Fig. 5].

The procedure consisted as usual of photographic documentation recording the condition of artifacts before conservation. The products of metal corrosion were removed in a bath of a 1% water solution of disodium EDTA using an ultrasonic washer for the purpose. Items were then desalinated in distilled water using the washer. Where necessary, products of corrosion were removed with a glass fibre pen. Artifacts were then protected with a 3% solution of Paraloid B-72 in toluene (Phenix 1992) and final documentation made. [PZ]
